SUBJECT: INSPECTION REPORT – West Bay Exploration Co, Jackson County, Michigan

Facility: Hilden-Rovsek 16 Facility, Norvell Township

Date of Inspection: August 28, 2014

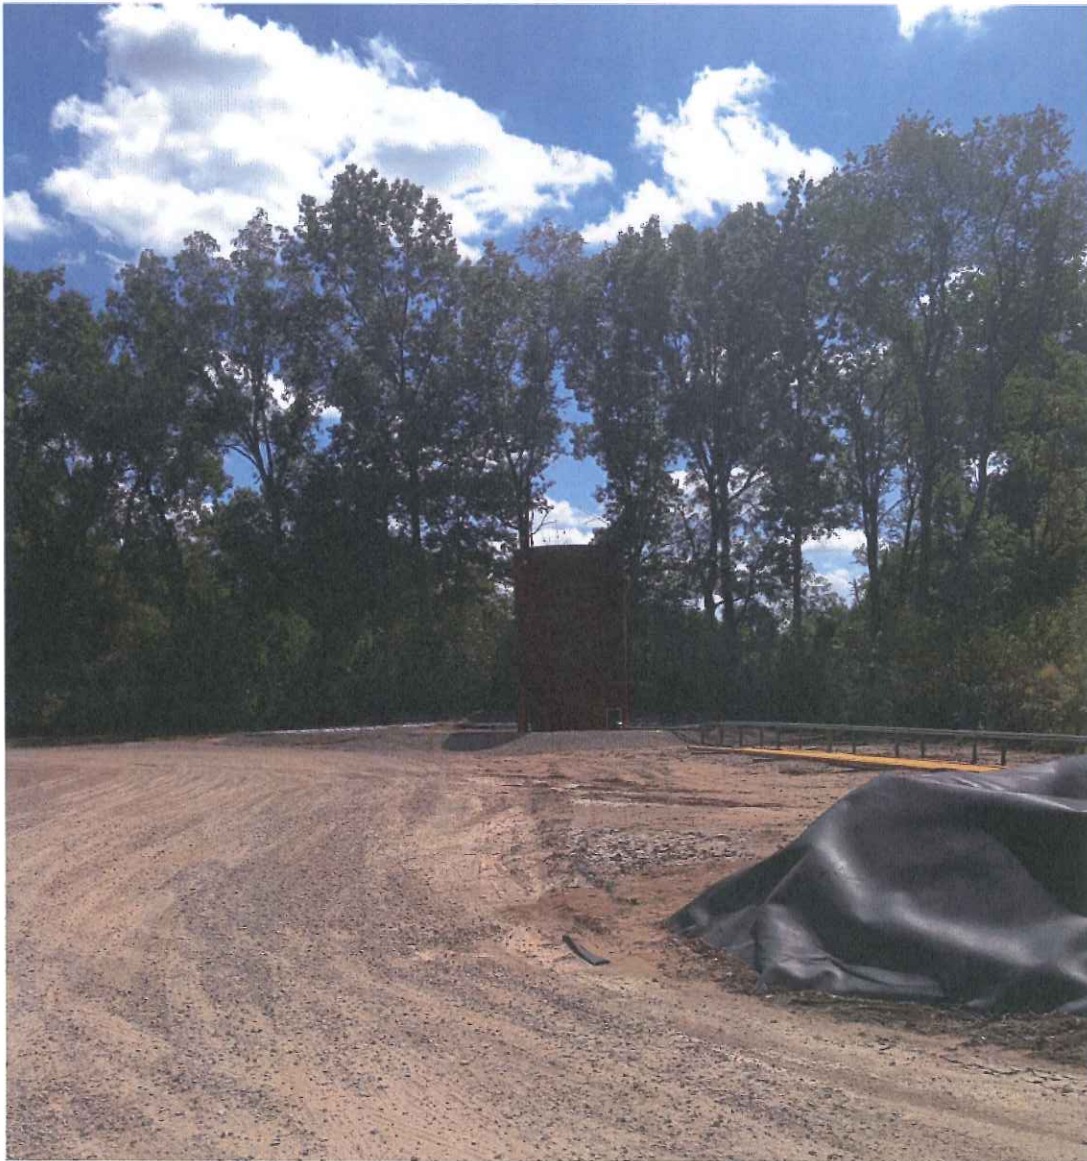
I took some photos of the overall facility (see photos section) and viewed the flare with the IR camera (a FLIR GF320). No visible emissions (with the naked eye) from the flare were present at that time. I climbed the stairway of the tank battery and viewed each of the thief hatches with and without the IR camera. There was a noticeable petroleum odor along the walkway. The IR camera showed all the thief hatches leaking continuously (see IR Video Log and diagram).

1) Flare

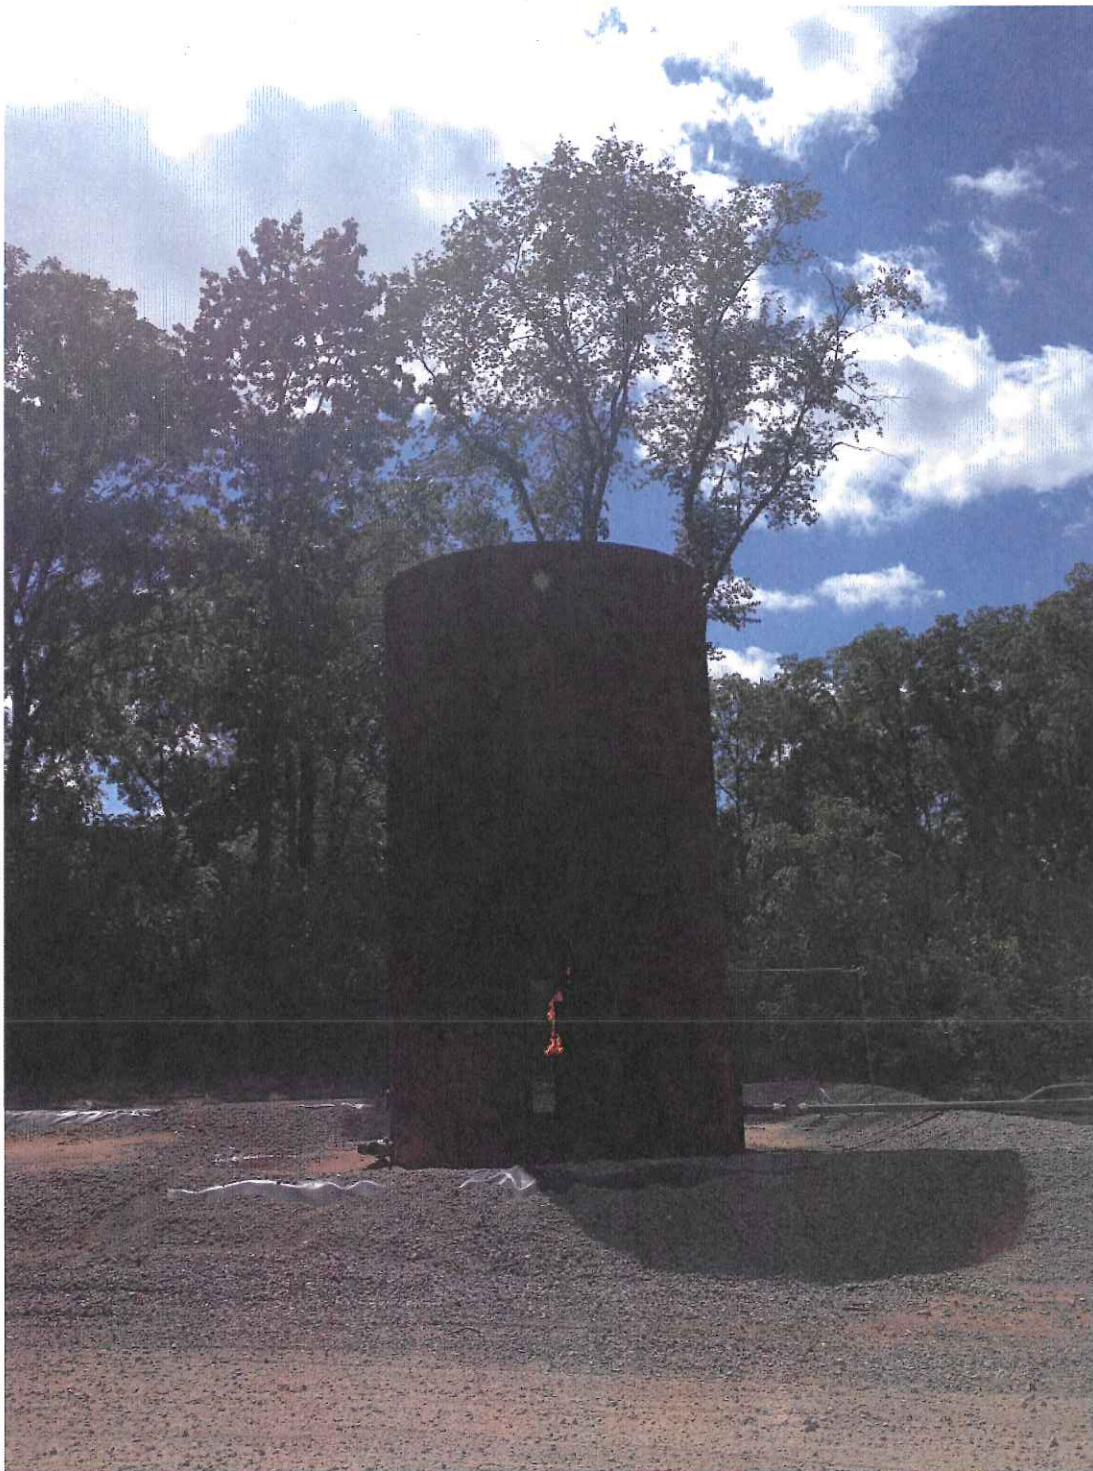
2) Flare, showing lit.
